AGARD REPORT 809

POD Assessment of NDI Procedures Using a Round Robin Test

Published January 1995

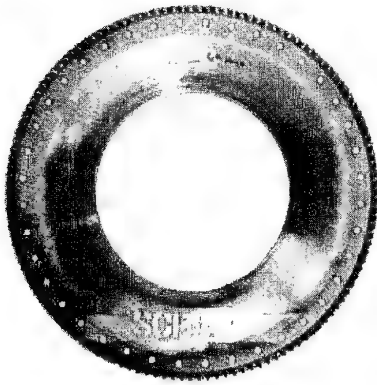
The test components used in this study were service-expired compressor disks and spacers from the J85-CAN40 engine (Figures 1 and 2). Although, they were originally operated under the safe-life philosophy, these parts had remained in service beyond the safe-life-limit due to logistic problems with part replacement. A total of seven sixth stage compressor disks and six fourth stage spacers were employed. The disks and spacers are fabricated from precipitation hardened martensitic stainless steel (AM355). Each disk has 40 bolt

Figure 1. A compressor disk of the type used in this study.

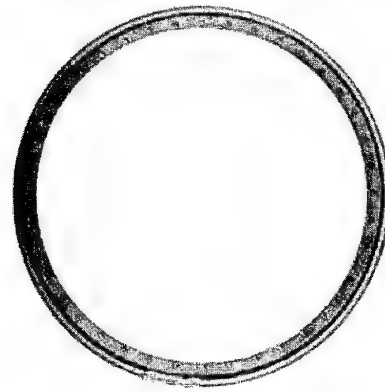
Figure 2. A compressor spacer of the type used in this study.

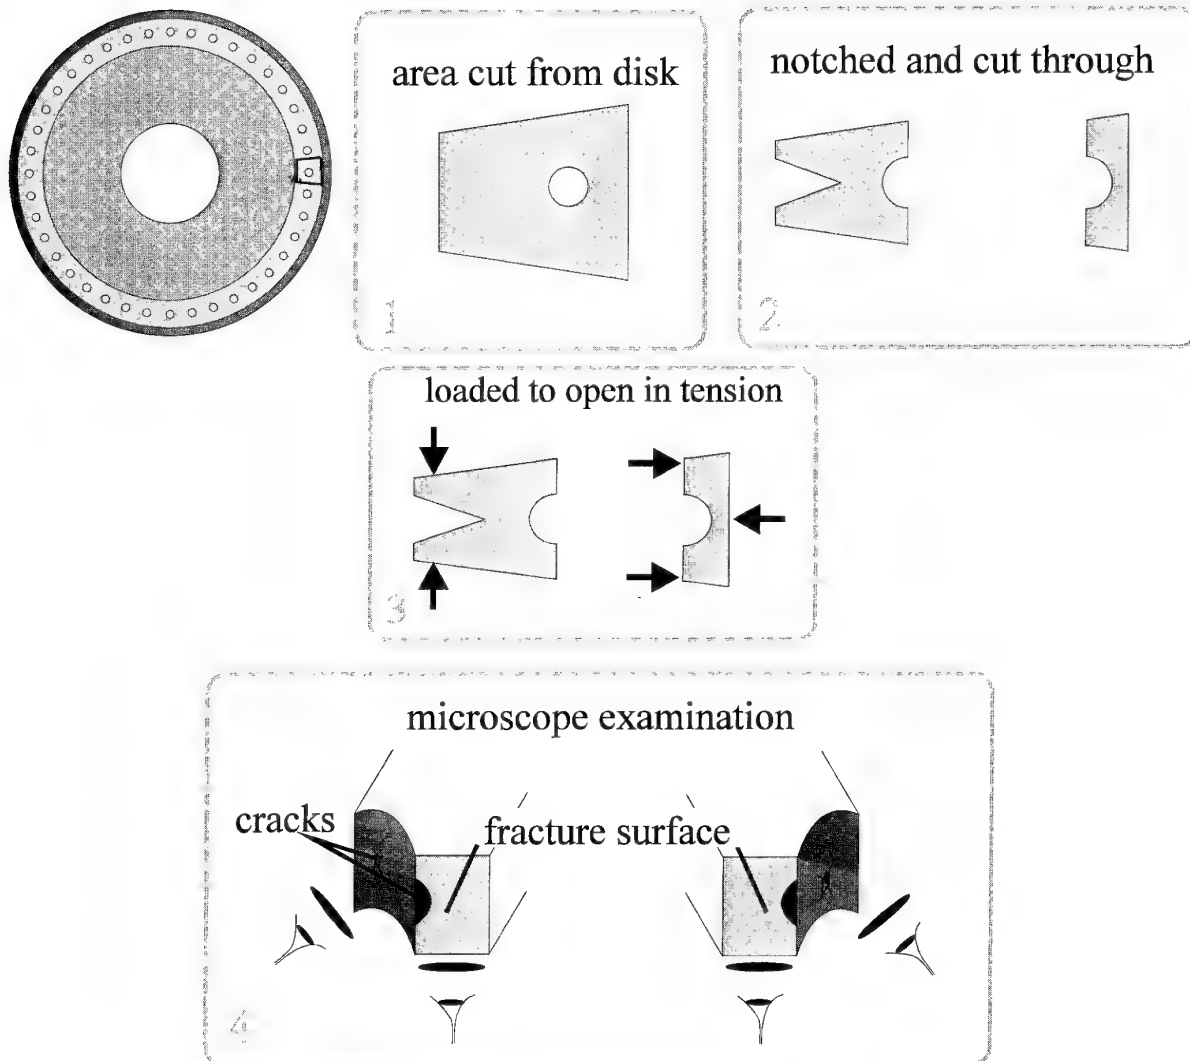
After completion of all NDI, the existence of cracks in the bolt holes was verified by destructive testing. The destructive crack verification was carried out at IAR/NRC on every component except for three disks (No. D, F and G). These disks have not been returned to Canada. The crack verification process is schematically illustrated in Figure 3. First, approximately 2cm x 3cm samples were cut from the region surrounding each bolt hole using a laser cutting technique. Each sample was then sectioned into two pieces along the diameter of the bolt hole. In the inward piece (the larger section), a notch was introduced in the side opposite to the bolt hole and the sample was then pried open by closing the notch in a vice. The second piece was loaded in three-point bending until failure. In both cases, crack faces were under tension during loading. To monitor the pry opening process, the sections were examined periodically under an optical microscope to check the crack opening and if multiple crack sites existed. After pry opening, the fracture surfaces were examined under an optical or a scanning electron microscope (SEM) as required depending on the crack size. Under the microscope, the service-induced LCF cracks were easily recognized from the rupture failure due to their smooth and oxidized surfaces and the crack size was measured. The specimens that did not reveal a crack on the fracture surfaces were further examined on the bolt hole surface to make sure that a crack was not missed during the pry opening operation.

Figure 3. Schematic illustration of sectioning, pry opening, and microscope examination of bolt hole specimens.

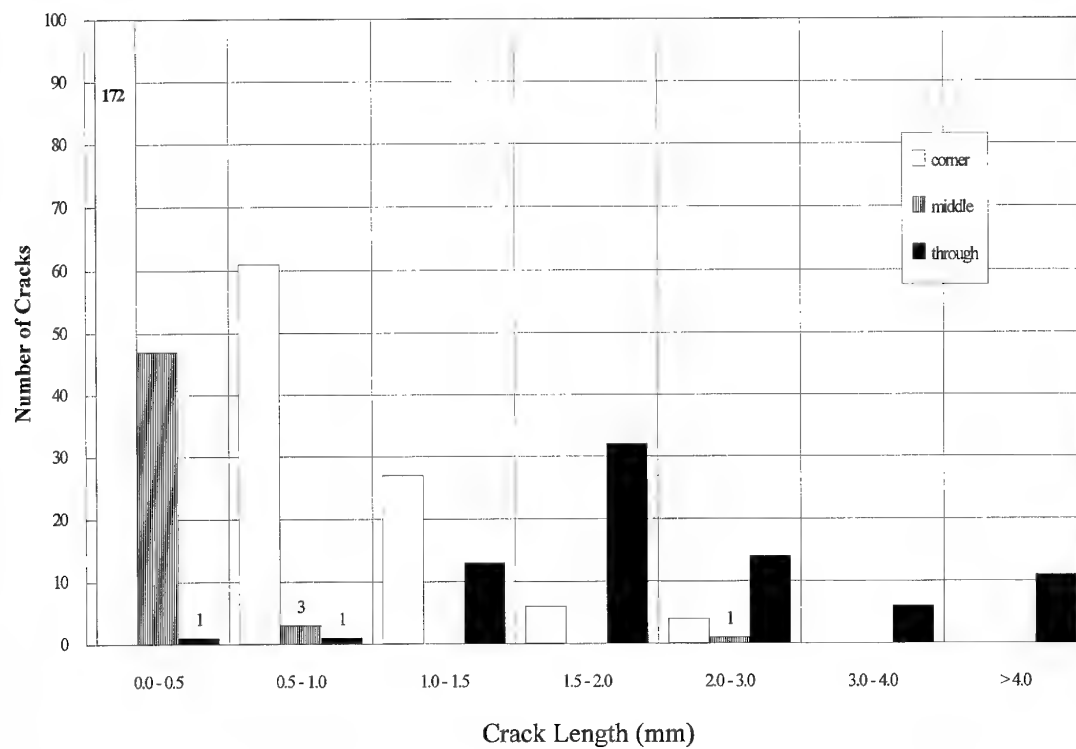
Destructive tests and examination of fracture surfaces indicated that most cracks initiated near the edges of the holes and formed corner cracks. Often, initiation occurred at the bore of the holes and grew radially inward towards the centre of the component. There were cracks which did not touch the top or bottom surfaces and these were termed middle cracks as well as cracks which touched both surfaces and were referred to as through cracks. Examples of different crack types are provided in Figures 4 and 5. Figure 6 provides the distribution of different crack types as a function of crack length indicating that the majority of cracks were small (less than 0.5 mm in length) corner cracks. Most holes had a single crack but multiple cracks, as many as seven, were also seen in many holes. Some cracks did not occur along the radii of the discs; many of these were initiated at what appeared to be voids or inclusions in the material and were often accompanied by larger cracks on the radii. Some totally internal cracks as well as outward propagating cracks were also seen.

Figure 6. Histograms showing the distribution of crack types as a function of crack length

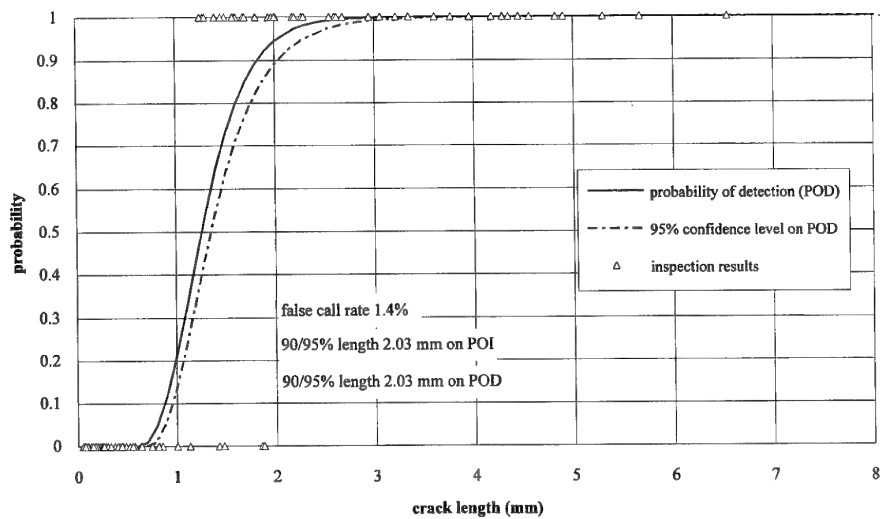
Although an attempt was made to inspect all components using the ultrasonic leaky-wave approach, only results for the disks were considered complete since the geometry of the spacers did not allow inspection of inner surfaces by this method. Therefore, only the data for disks were analyzed and the POD curves are shown in Figure 25. The false call rate was 1.4%, the largest crack missed was 1.8 mm and the 90/95% crack length was 2 mm. These results are very similar to those obtained in the previous investigation using similar disks [1,9].

Figure 25. Dependence of POD on crack length, ULI organization IV

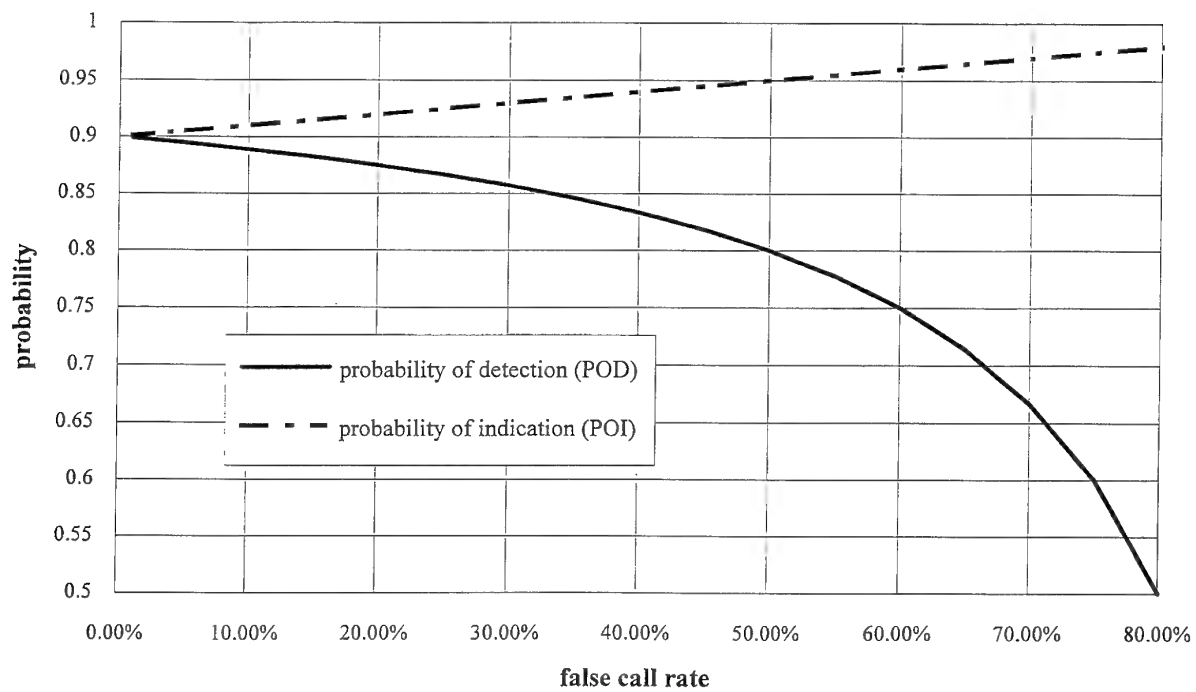
If noise is present in the response signal, false indications can result if noise response from a crack-free site is interpreted as being caused by a crack. False calls are undesirable for economic reason, but often there is a trade off between the false call rate and the ability to detect small cracks. As shown by the POI and POD curves as well as the associated 90/95% crack length values, for a given inspection procedure, high false calls only marginally improve the chance of identification of cracks. However, the true probability of detection (POD) decreases more with increasing false calls as illustrated in Figure 26 for a typical inspection with a 90% true POD and no false calls. This indicates that every inspection process has a certain detection limit indicated by the signal-to-noise ratio which is governed by many factors including the physics of the procedure, instruments and settings employed, signal processing methods, the test material and geometry, the operator, etc. Hence, any attempt to increase the number of hits by such means as using high instrument gain or low threshold level and deliberately identifying noisy signals as cracks without improving the signal-to-noise ratio will only marginally increase the probability of indication but not the true probability of detection.

Figure 26. The effect of false call rate on probability of detection (POD) and probability of indication (POI)
